Thorn Run Dam, NDI Number PA-271.
Ohio River Basin, Thorn Creek, Butler County,
Pennsylvania. Phase I Inspection Report.

PHASE I REPORT
National Dam Inspection Program

Thorn Run Dam

31 August 1978 and 5 September 1978

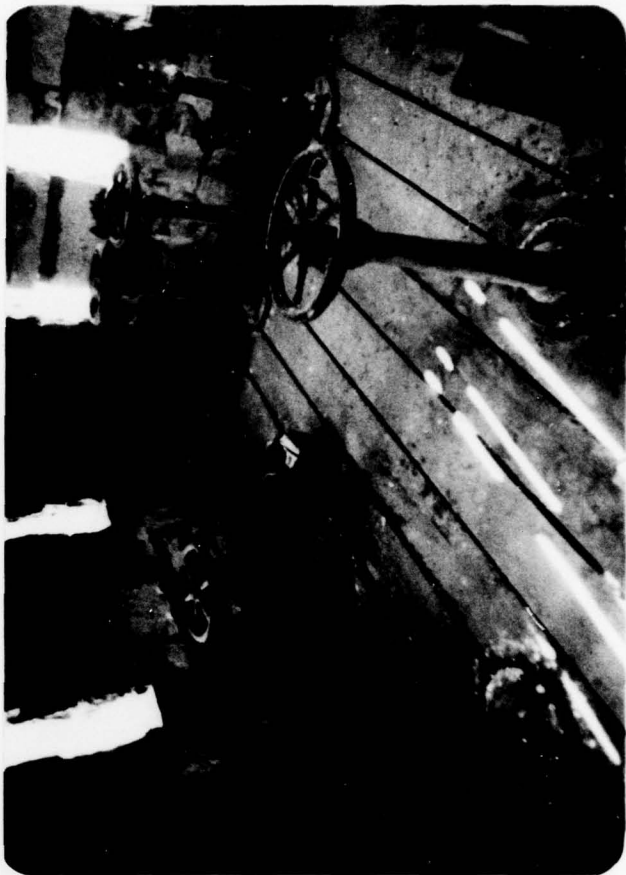
Within the interior of the gate house, six manual controls were observed. As indicated previously only three of the controls are currently utilized in the operation of the outlet system. The condition of the valves associated with the controls is not known. They are reportedly operated several times a year as needed (see Photograph 8).

PHOTOGRAPH 8 View of the interior of the gate house. The three floor stand valves in the background operate the intake gates. The three near valves operate supply and blowoff lines.
